GEOTAB

Accident Reconstruction

Case Study: Front end Collision

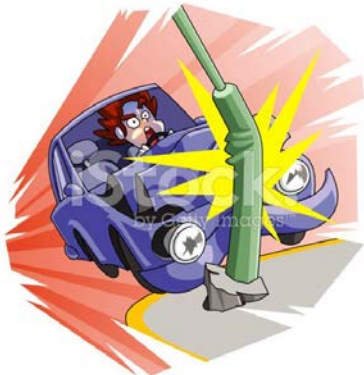
- The GO device will detect an “accident level event” when a vehicle collision occurs and the accelerometer threshold exceeds 2.5G (front or back, or side to side)
- During this “event” the GO device will record second-by-second data of the accident at 100 Hz frequency.
- This data is automatically transmitted to MyGeotab for interpretation.

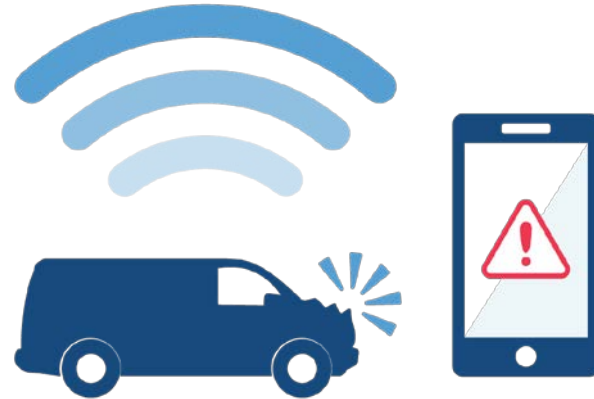
What types of data are sent during an Accident Level Event?

The main sets of data sent are:

- + Latitude, longitude
- + Speed
- + Accelerometer
- + Other sets of data normally recorded, such as Engine Data, Auxiliary information etc. can be used in conjunction with this data to reconstruct the accident

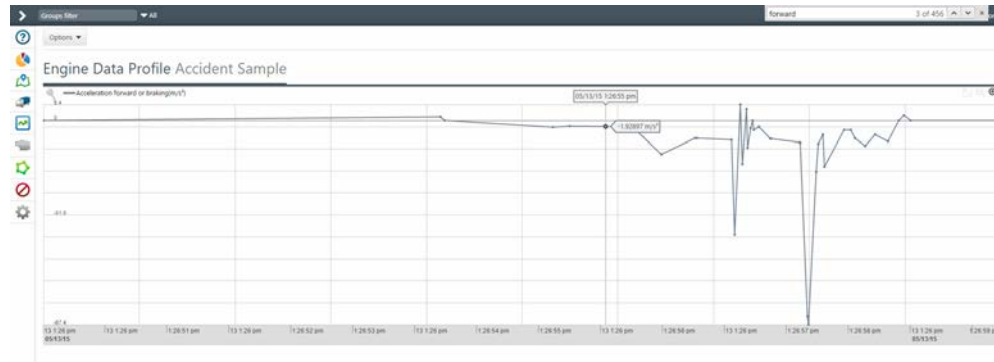
Step 3: Accelerometer Graph

The accelerometer graph is a useful tool that can be used to determine the direction from which the vehicle was hit and the relative force exerted in each direction due to the collision.

This information is available by going to Engine & Maintenance > Engine Data > [Engine Measurements](#).

- 1) 'Acceleration Side to Side':
 - a) **Negative** values represent acceleration to the **right**
 - b) **Positive** values represent acceleration to the **left**
- 2) 'Acceleration forward or braking'
 - a) **Positive** value represents **forward** acceleration
 - b) **Negative** represents **backwards** acceleration

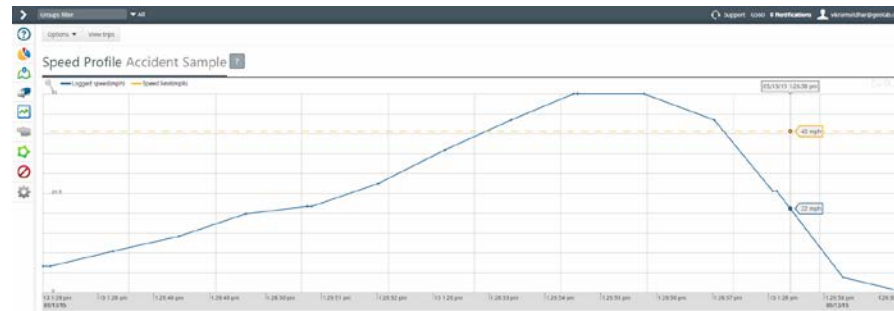
Speed Profile

The Speed Profile is a great tool that shows **vehicle speed** vs. **time**.

- This can be used to accurately determine the speed of the vehicle in question at the time of the accident.

Below is the Speed Profile of the vehicle before, during, and after the accident.

- + Driver was speeding (Driving above speed limit)
- + Driver was overrevving the Engine
- + Did attempt to avoid the accident (we see both Braking and turning towards the right to avoid the accident)
- + There were some fault codes that came up after the accident
